# Failure Analysis Of Journal Bearings Of Tyre Moulding Press

Yuvaraj, N., K.Manohar Shenoy<sup>1</sup> and K. Gopinath<sup>2</sup>

Dept. of Mech. Engg  
IIT Guwahati  
Guwahati – 781039

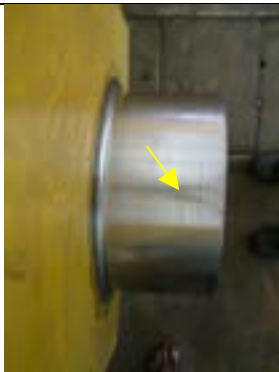
Fig.1 shows one of the crank pins journal portion showing the scratch mark. Close up view of these scratches in Fig.2 indicates that the surface has been plowed by some particles harder than steel. The scoring is found to cover part of the circumference only. Burrs adhering to the grooves can be seen at a few places in Fig.3. The mating bush bearing with the above journal is shown in Fig. 4. A deep groove corresponding to the

Fig. 1: crank pin journal portion showing scratch marks.

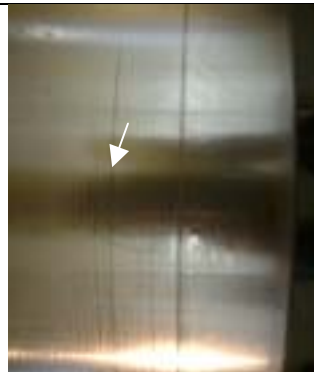
Fig.2: Close up view of crank pin journal showing deep scratch.

The deep grooves observed on bushes and journals are akin to plowing by a single point tool which is an abrasive wear. For such a damage the cutting edge has to be harder than the both the surfaces. This situation is promoted by the ingress of the particles of slag or work hardened steel chips, chilled grinding swarf or chilled molten steel material from the welding seen in the grease samples. It is likely that hard particles got embedded in the bronze bush and abraded the steel surface. During the reverse rotation, the burr formed in the crank journal surface has caused the abrasion of the bush (Fig.5). The burr has also dislodged the particle into the lubrication channel and it has not caused further damage. This is inferred from the scratch mark extending from one lubrication channel to the other and scratch formation extending only to 1/3 of the journal surface Figs. 1 & 4. The iron chips whose hardness is more than 400 VHN and slag particles whose hardness is about 1000 VHN are potential dangers from the abrasive wear considerations as the crank surface hardness was 220 to 250 VHN and bronze bush was 90 to 120 VHN.

The source of entry of iron particles is found to be from the adjacent machining spot, welding region on the press after the mounting of the cranks, grinding zone on the press surface. In fact, the press was not fully cleaned and machining chips were seen in some of the pockets in the press. Air blowing of the surface of the press was the most undesirable method of cleaning, that too after mounting the crank with greased bearing. The cranks were stored in the shop floor and in adjacent area surface grinding was performed with hand grinder. Further, the crank and the bush mounting press were not cleaned before the mounting operation. The mounting press was full of dust as welding and grinding operations go on all around with giant size fans running all the time for worker's comfort. Hence, it is suggested that the cleaning operation should be done with vacuum cleaner or wet cloth which will prevent the fluidization of the particles and contamination.

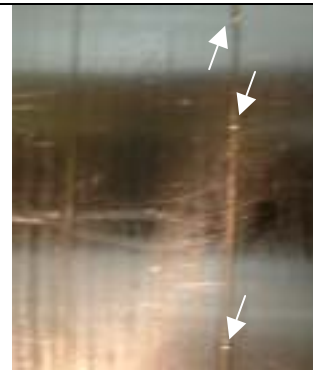
Fig. 3: Close up view of the scratch showing burrs adhering to the surface.

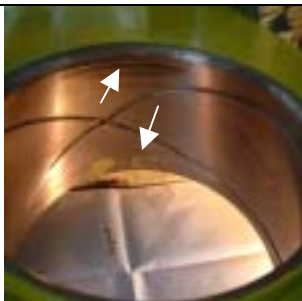
Fig. 4: Bush bearing with scratch mark at the lower end and dark adhesive wear patch at the top end.

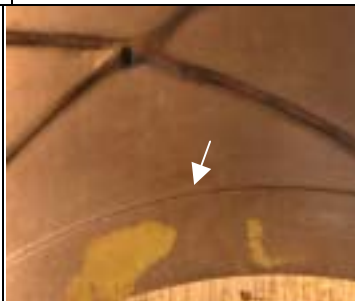
Fig. 5: Enlarged view of the bush bearing showing deep scratch mark at the bottom edge.

one in the journal can be seen. The enlarged view of this is in Fig.5. Dark patches can be seen at some portions of the bearing in Fig.6. It was noticed that journal near the root portion was built up by welding to fill the blowholes and then hand finished. It appeared to have uneven surface. In some journals, scratch marks and smearing of bronze were seen in the axial direction (Figs. 3 & 7). This sort of cross marks can occur either during the assembly or the disassembly. If during the assembly fresh grease is used and proper care is taken, then this could have occurred during the disassembly with the bearing exposed to atmosphere partially which make it possible for the ingress of dust.

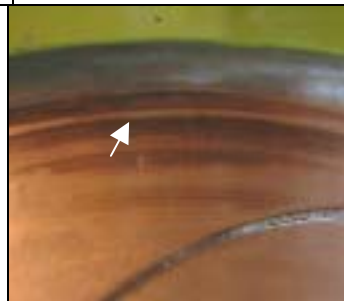
Fig. 6: Enlarged view of the bush bearing showing the black adhesive marks at the top edge.

lead to adhesive wear as the contact pressure was found to be of the order of 72.7 MPa. Such an adhesive wear of the bush due to unevenness of journal surface is seen in Fig.6 due to metal to metal contact. This can be avoided by replacing hand grind finishing proper machining of the built up portion to obtain conformed surface.

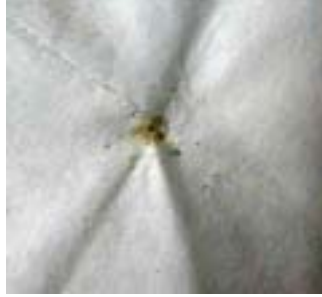
Fig. 8: Dust particles in the grease of the LHS bearing.

Fine dust particles in agglomerate condition found in the LHS bush and journal grease are shown in Fig. 8 and 9. The dust was similar to shop floor dust. Similar dust particles were seen in the RHS bush and journal grease. However, the dust in the top bush and journal was much less. The size of the particles was between +5 and -44  $\mu\text{m}$ . Various iron particles found in the grease are shown in Fig.10 to 15. Particles of droplet, curly chips, brittle chips and grinding swarf were seen. Some chips had sharp edges. All these chips were in work hardened condition. The size ranged from 44  $\mu\text{m}$  to 10 mm.

The small content of dust particles which found in the grease is very fine in nature and hence they cannot bring about deep abrasive wear. They may cause polishing type of wear (mild abrasion) which can help to some extent in conforming the two surfaces. Hence they are considered harmless in the present context. However, their entry into the working surface is not advisable. The source of their entry is found to be fluidization of the floor dust during sweeping, mopping the press surface with dry cloth and while handling of the parts, and air draft cleaning of the press surface.

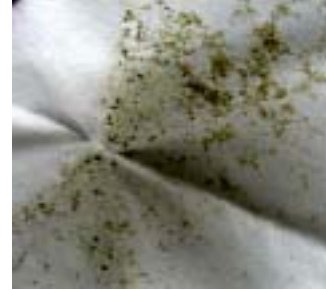
Fig. 9: Dust particles in the grease of LHS journal.
